**BALCONY AND DECK INSPECTION**

1501 – 1567 Riverside Dr  
Tulsa, Oklahoma

November 19 and 20, 2012

**RE: BALCONY AND DECK INSPECTION OF CONDOMINIUM COMPLEX AT  
1501 – 1567 RIVERSIDE DRIVE, TULSA, OKLAHOMA  
FILE #12403 Structural**

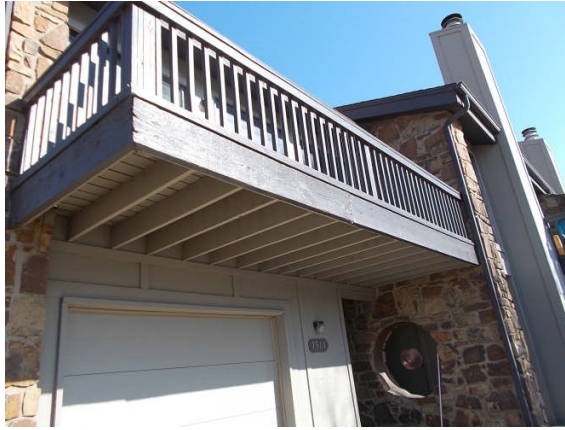
1. 1501 balcony. 6'x19'.

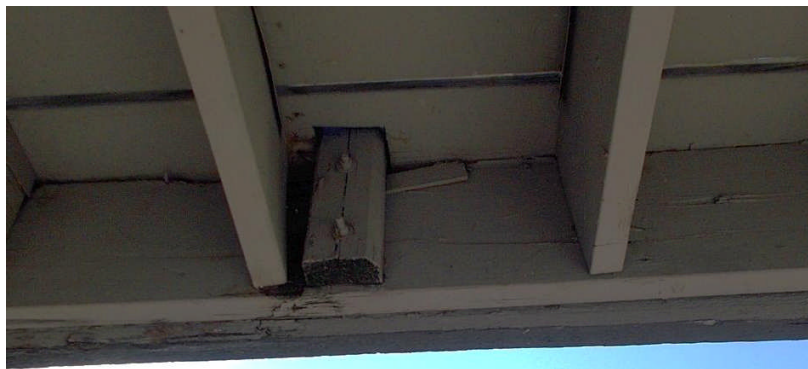
<b><u>Address:</u></b>	<b><u>Deck size:</u></b>	<b><u>Comments:</u></b>
1501	6' x 19'	Decay at rim joist. Replace 2x10 rim at edge of balcony.
1503	6' x 10'	Screen on handrail is different; joists appeared normal.
1505	6' x 10'	No problems observed.
1507	6' x 19'	Trex synthetic deck; minor rot at end of joists; joists need paint.
1511	6' x 19'	Trex deck; Rim pulling away from joist; add joist hangers.
1513	6' x 10'	Decay at one joist and 2x12 cedar rim. Replace joist and 2x12 cedar rim.
1515	6' x 10'	Flower planter bending handrail; joists need paint; rot at blocking above garage door. Replace decayed blocking.
1517	6' x 19'	Past repairs to south end of deck; joists need paint.
1521	6' x 19'	One rotten joist; one split joist. Decay at 2x12 rim. Replace split joist and decayed joist and rim. Remove Astro turf and stain deck. Spray with anti-fungal primer.
1523	6' x 10'	Paint joists and stain deck.
1525	6' x 10'	Joists appear normal. Trex handrail cap is a good idea.

2. Decay at rim joist.

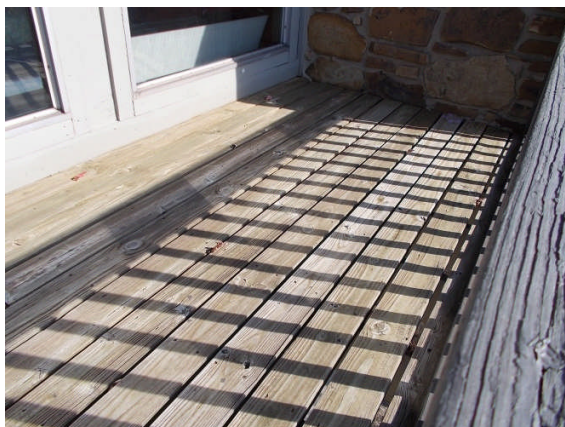
3. 2x6 treated decking; no stain.

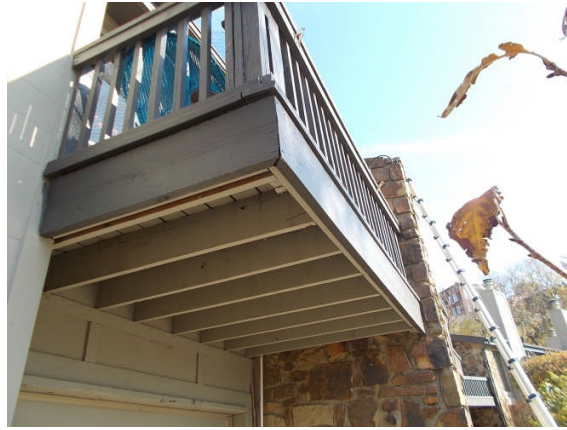
**4. 1503 balcony. 6'x10'.**

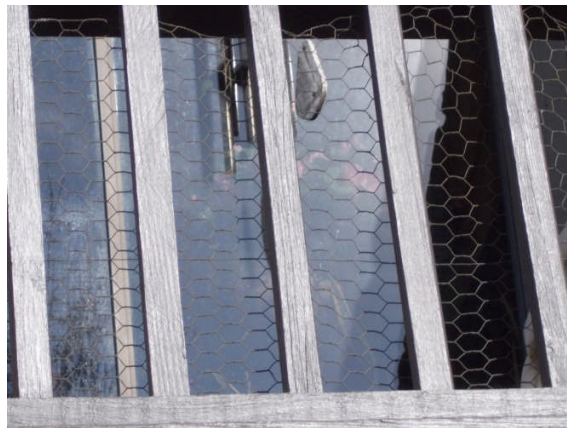
**5. Chicken wire on balcony.**

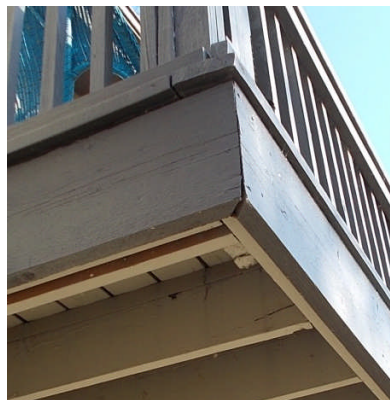
**6. 2x12 cedar trim at edge of deck.**

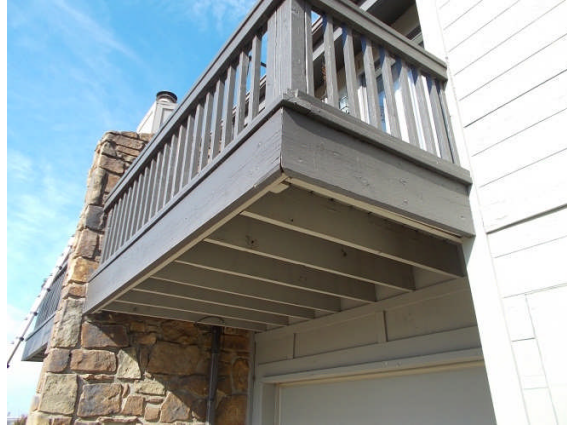
**7. 1505 balcony. 6'x10'.**

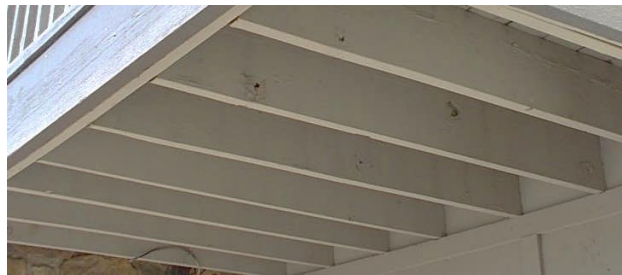
**8. Joists appear normal. 2x10@16; cantilevered.**

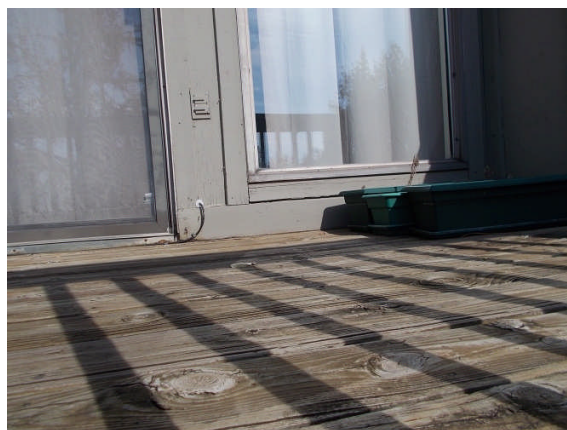
**9. 2x6 decking appears weathered.**

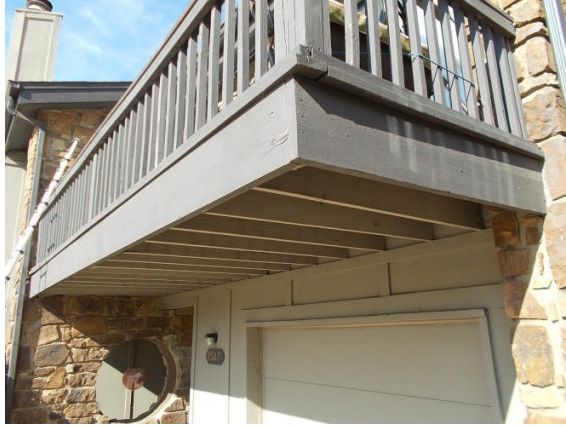
**10. 1507 balcony. 6'x19'.**

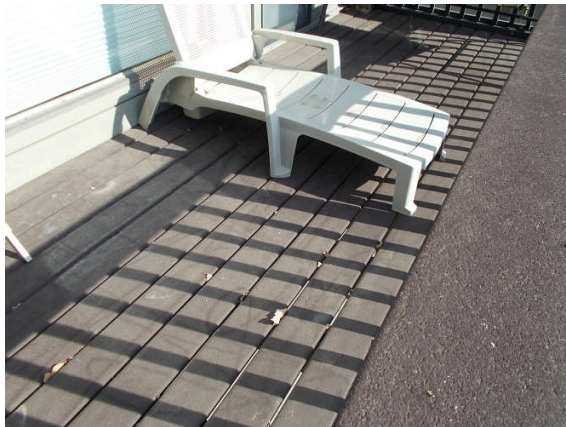
**11. Synthetic Trex decking. Very durable.**

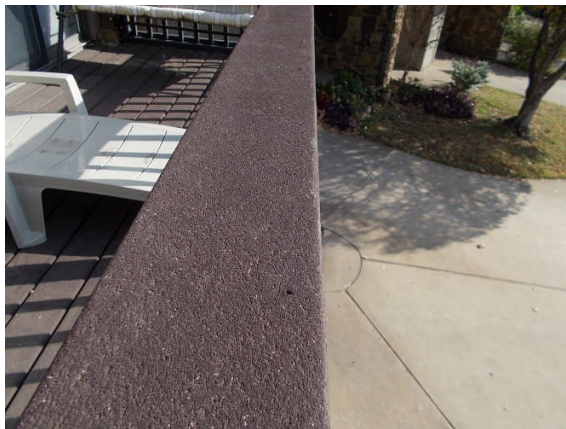
**12. Synthetic Trex material used for handrail cap also. Nice.**

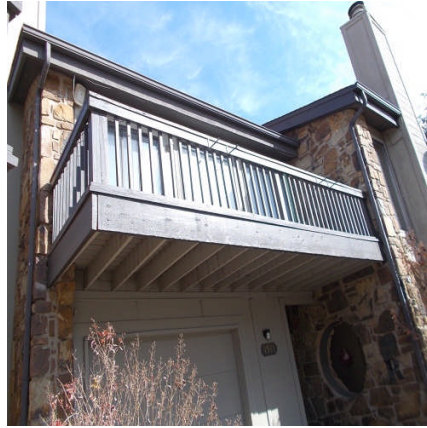
1511

**13. Balcony 6' x 19'.**

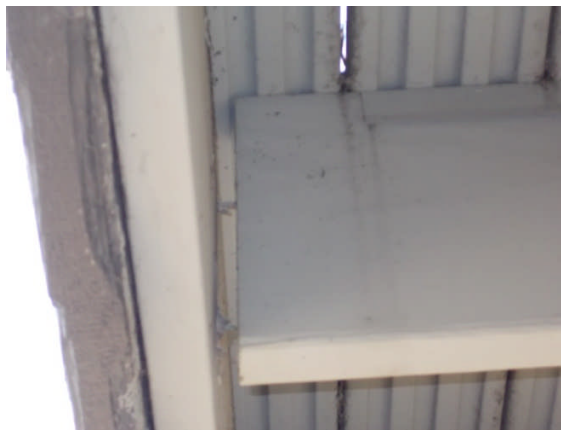
**14. Rim pulling away from end of joist.**

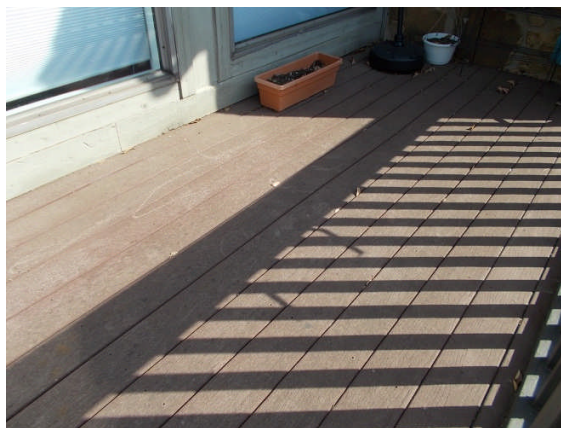
**15. Synthetic Trex decking.**

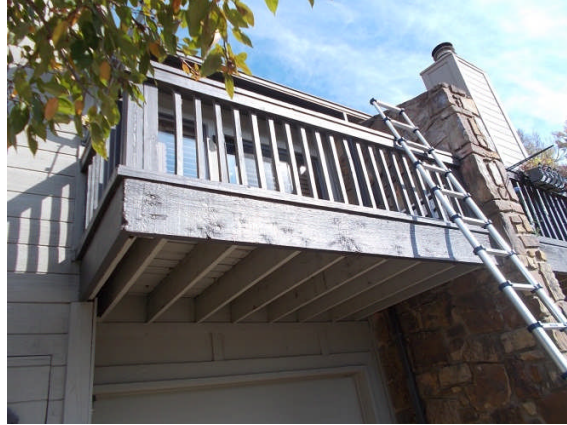
**16. 1513 balcony. 6' x 10'.**

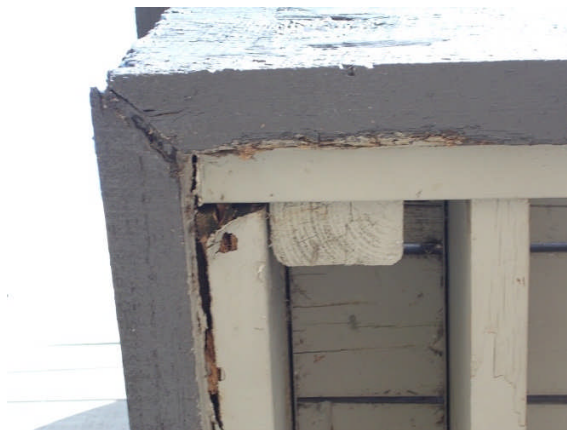
**17. Decayed joist at east end.**

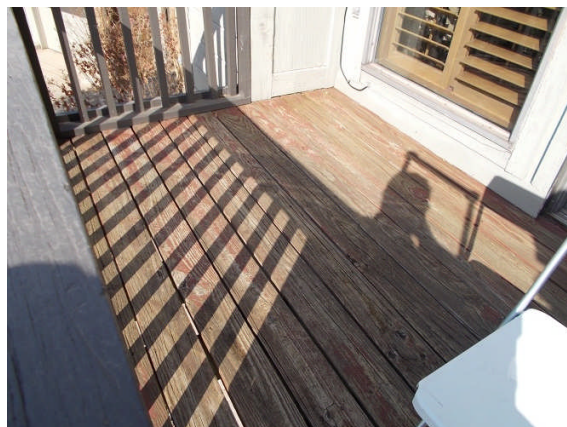
**18. 2x6 treated decking.**

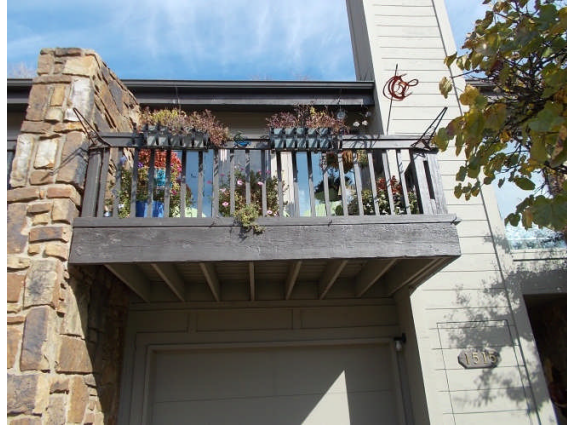
**19. 1515 Balcony; best flowers. 6' x 10'.**

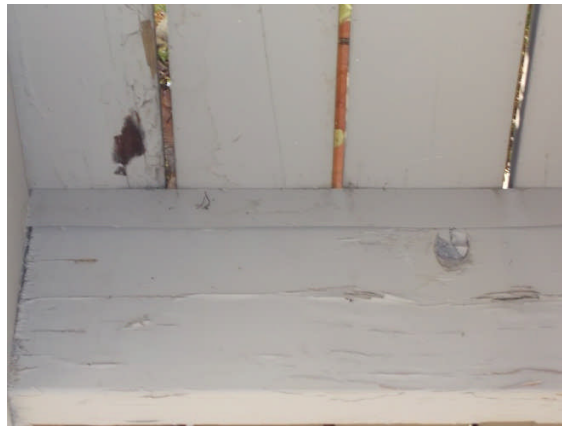
**20. Some minor dark fungus growth observed.**

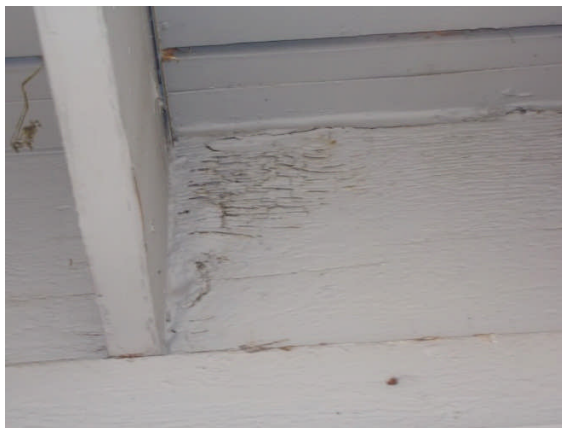
**21. Decayed blocking above garage door.**

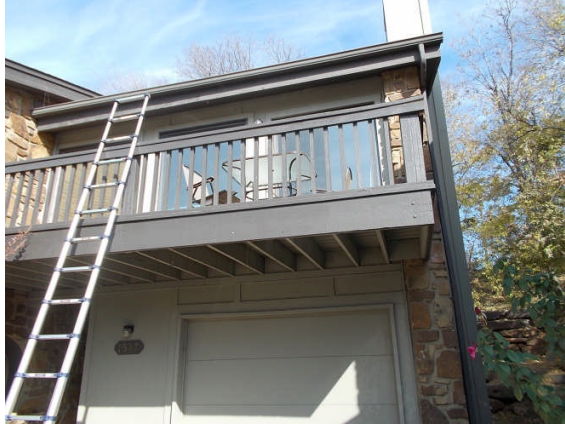
**22. 1517 Balcony. 6'x19'.**

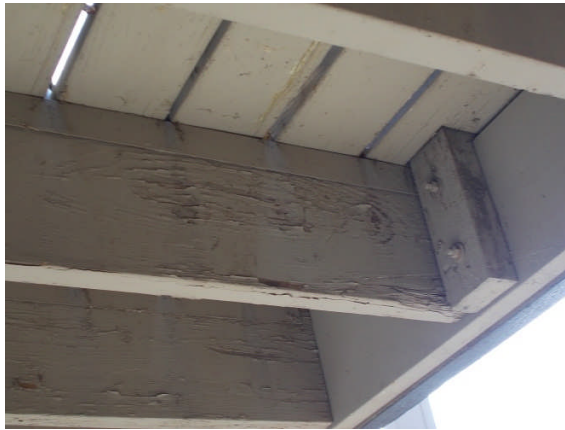
**23. Peeling paint on joists.**

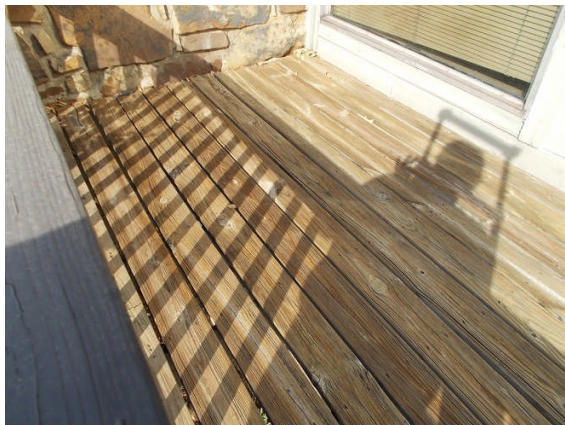
**24. 2x6 treated decking.**
